# TSD File Inventory Index

Facility Name: <u>Dexam Industrial Packaging (the Federal Site)</u>		
Facility Identification Number: <u>ILP 005 205 604</u>		
<b>A.1 General Correspondence</b>		<b>B.2 Permit Docket (B.1.2)</b>
<b>A.2 Part A / Interim Status</b>		<b>.1 Correspondence</b>
<b>.1 Correspondence</b>	Y	<b>.2 All Other Permitting Documents (Not Part of the ARA)</b>
<b>.2 Notification and Acknowledgment</b>	Y	<b>C.1 Compliance - (Inspection Reports)</b>
<b>.3 Part A Application and Amendments</b>	Y	<b>C.2 Compliance/Enforcement</b>
<b>.4 Financial Insurance (Sudden, Non Sudden)</b>		<b>.1 Land Disposal Restriction Notifications</b>
<b>.5 Change Under Interim Status Requests</b>		<b>.2 Import/Export Notifications</b>
<b>.6 Annual and Biennial Reports</b>		<b>C.3 FOIA Exemptions - Non-Releasable Documents</b>
<b>A.3 Groundwater Monitoring</b>	Y	<b>D.1 Corrective Action/Facility Assessment</b>
<b>.1 Correspondence</b>	Y	<b>.1 RFA Correspondence</b>

**APPENDIX A**  
**Visual Site Inspection Photograph Log**

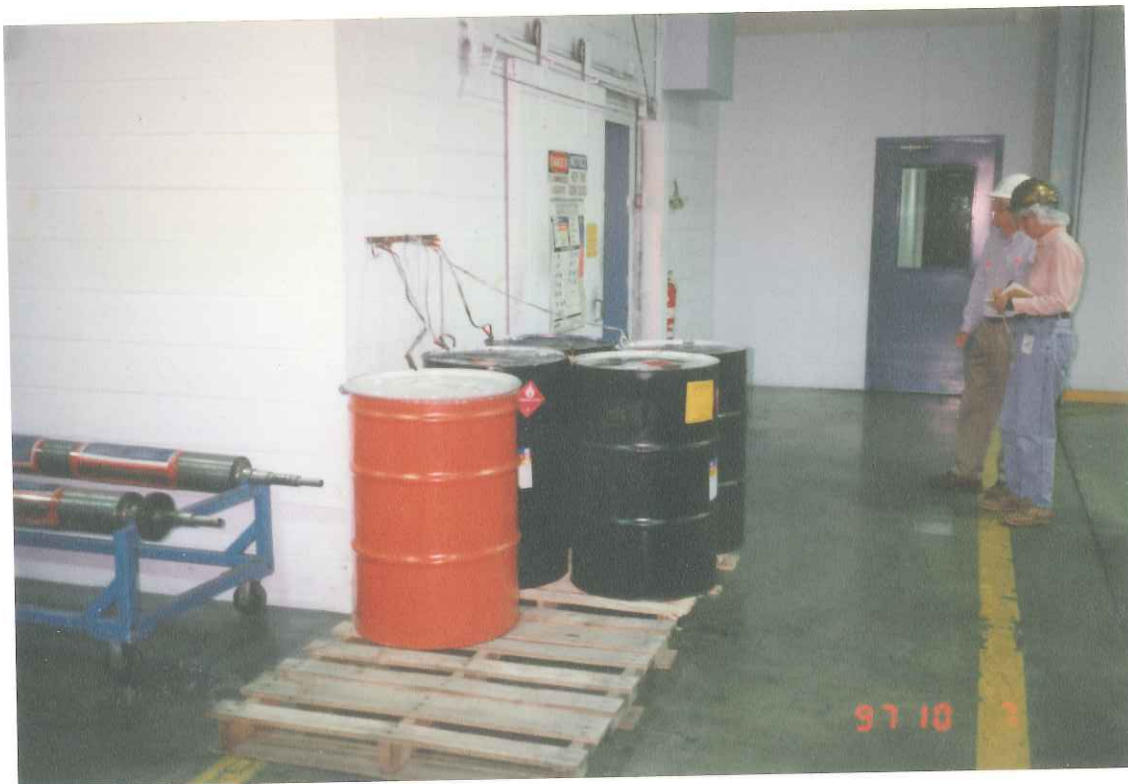
Report Photo No.: 1  
Log Book Photo No.: 1-2  
Date: 10/7/97

Description: View of Ink Room Temporary Storage Area (SWMU 1). Orange drum is dyne waste, other drums are waste solvent-based inks.

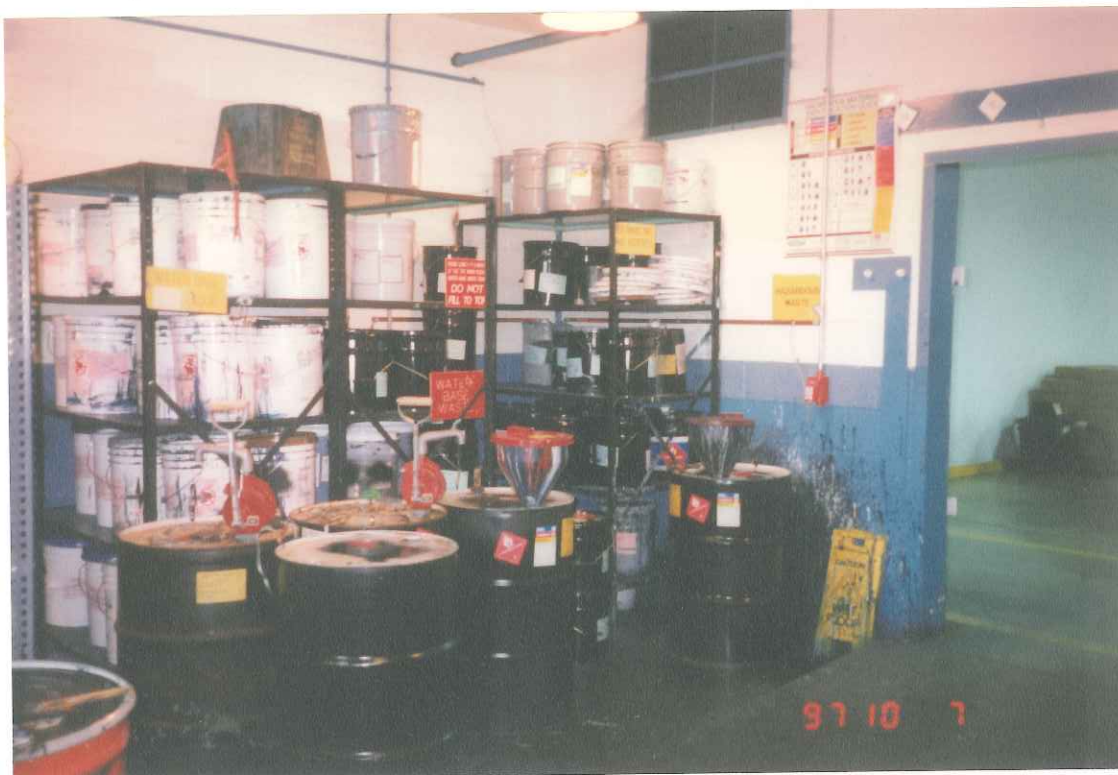
Report Photo No.: 2

Description: View of Ink Room Satellite Storage Area (SWMU 2). Waste solvent-based inks and waste water-based inks were present (drums with funnels) as well as one drum of dyne waste (orange drum on bottom left). Other three drums (two with pumps, one without) contain product water-based inks. Containers in shelving units contain product inks, both solvent-based and water-based.

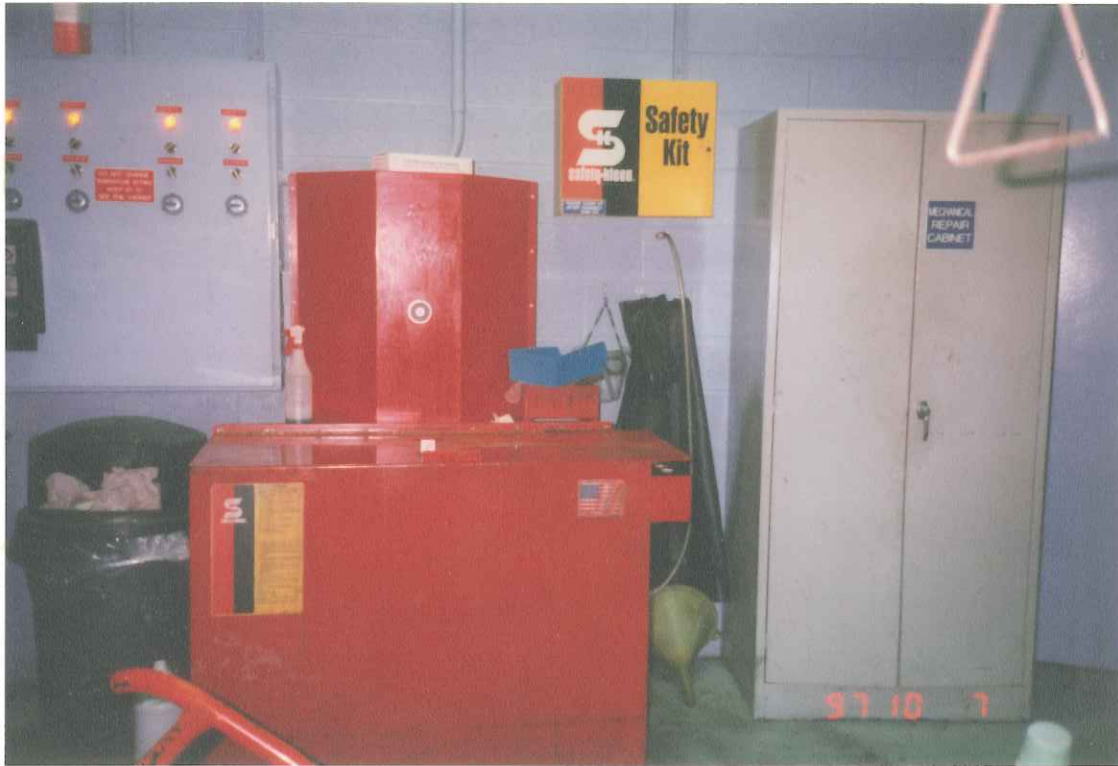
Report Photo No.: 4  
Log Book Photo No.: 1-6  
Date: 10/7/97

Description: View of the Safety Kleen Parts Washer (SWMU 4).

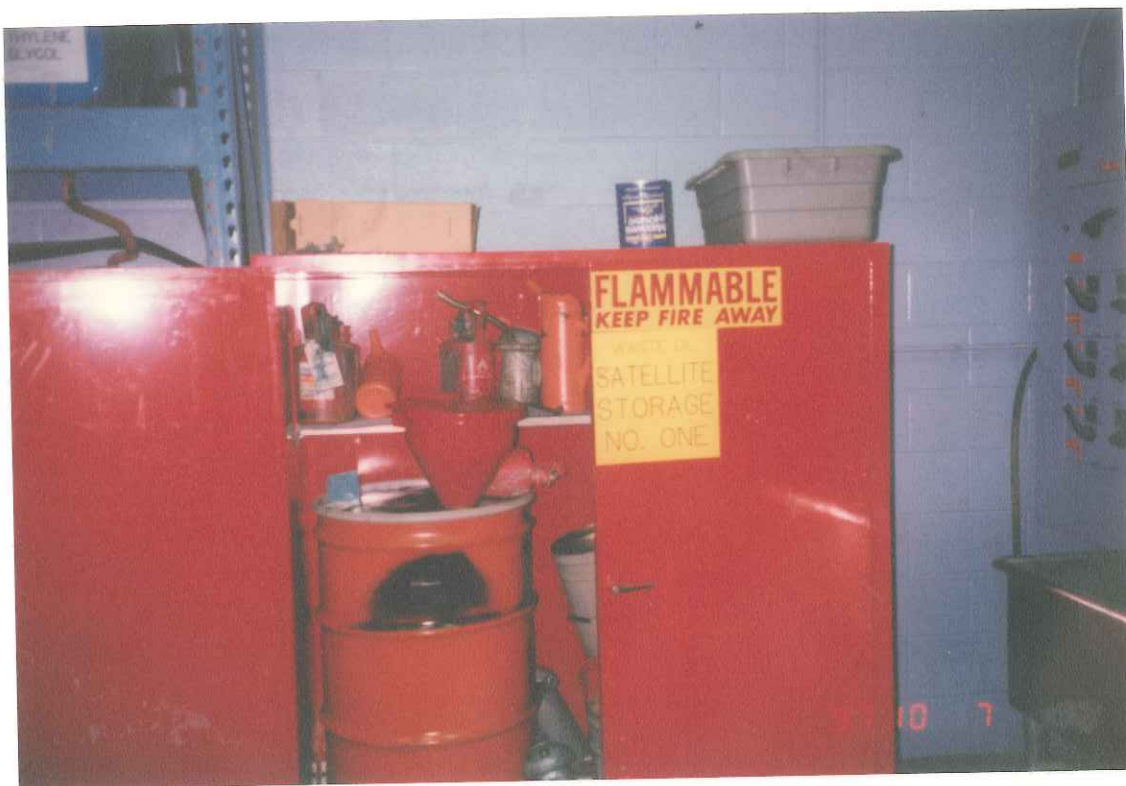
Report Photo No.: 3  
Log Book Photo No.: 1-5  
Date: 10/7/97

Description: View of Waste Oil Storage Cabinet (SWMU 3).

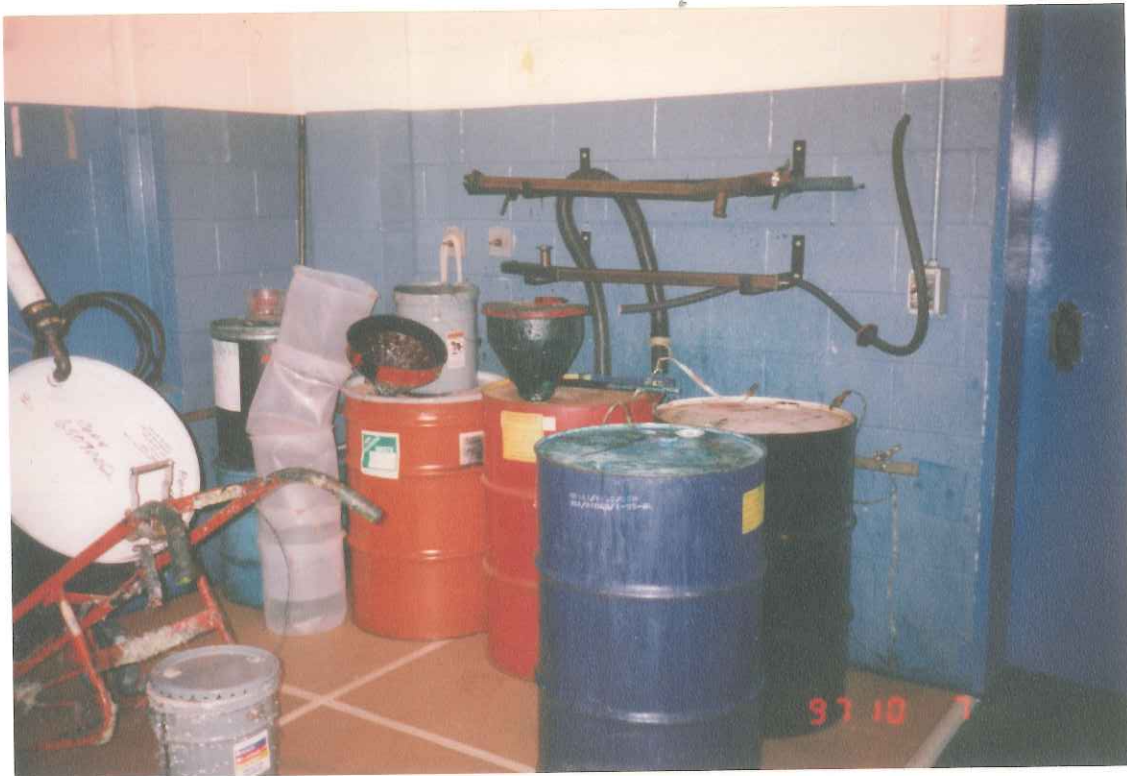
Report Photo No.: 5  
Log Book Photo No.: 1-7  
Date: 10/7/97

Description: View of southern portion of Adhesives Room Satellite and Temporary Storage Area (SWMU 5). The cardboard on the floor is reportedly used to ease maintenance since small, infrequent drips from transfer containers may occur. The floor below reportedly contains slight discolorations, though it has not received major spills.

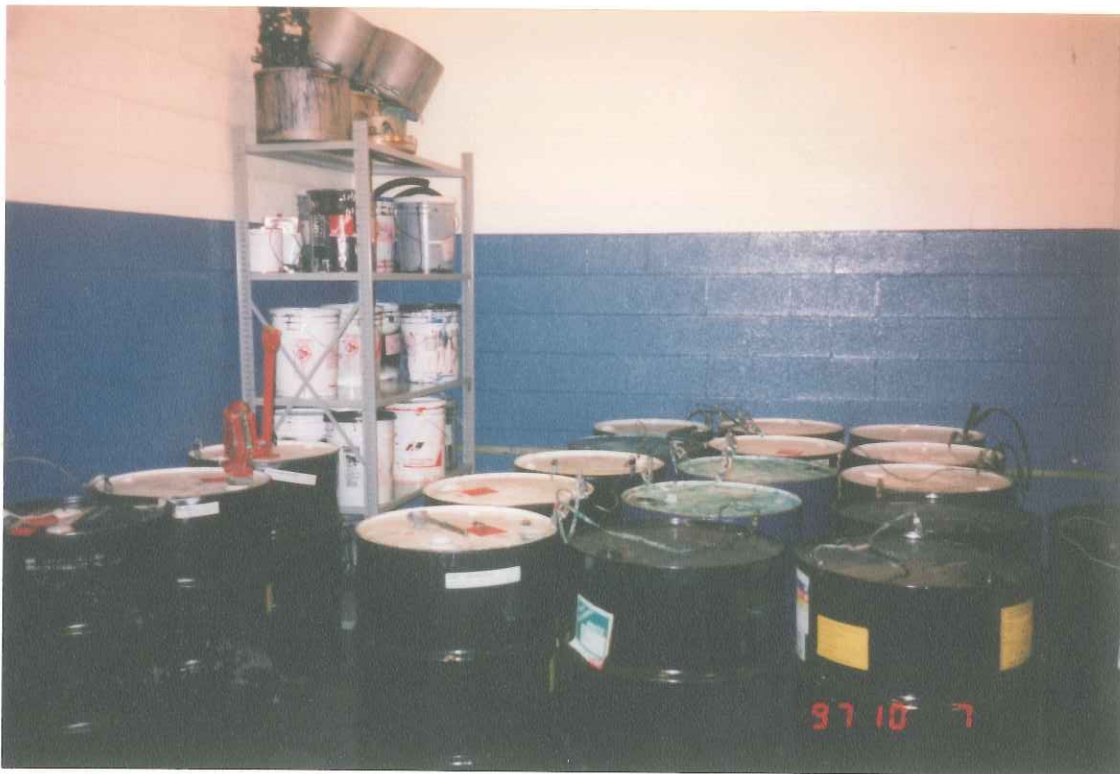
Report Photo No.: 6  
Log Book Photo No.: 1-8  
Date: 10/7/97

Description: View of a northern portion of Adhesives Room Satellite and Temporary Storage Area (SWMU 5). Only products were reportedly stored in this portion of the room, although during the VSI both waste and product drums were observed.

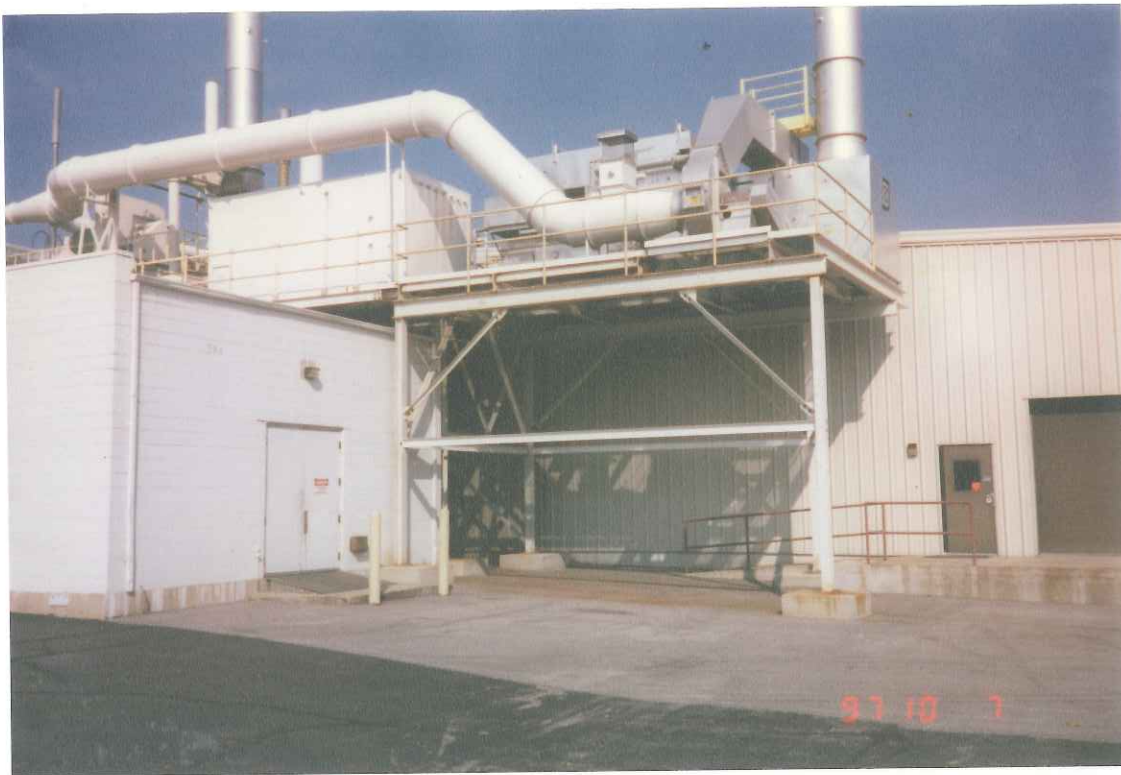
Report Photo No.: 7

The Former Product and Hazardous Waste Underground Storage Tank Area (SWMU 6) was identified as having a high potential for release. Soil sampling in 1992 identified elevated levels of methanol (85,400 ppb) and eight PNAs (e.g. benzo(a) anthracene: 810 ppb). According to a documented December 3, 1993 conference call between Illinois EPA (IEPA) and Rexam, IEPA reportedly granted closure for this unit with respect to groundwater monitoring, since no constituents were detected in groundwater above Class II standards. As indicated in the August 13, 1993 Revised Closure Documentation Report, a risk analysis was performed by CH2M Hill using U.S. EPA guidance documents. Results reportedly indicated the risk from these constituents to be two orders of magnitude below U.S. EPA action levels. An October 31, 1997 phone conversation with Mr. Jim Moore of IEPA indicates closure documentation is currently under review by IEPA.

In August 1992, soil sampling of the Former Product and Hazardous Waste Underground Storage Tank Area (SWMU 6) identified elevated levels of methanol and eight PNAs. Of the eight PNAs detected above IEPA soil objectives, benzo(a) anthracene was detected at the highest level (810 ppb), nearly 100 times the IEPA objective of 8.7 ppb specified in the June 1, 1992 letter to Baxter. The maximum concentration of methanol in soil samples was 85,000 ppb, nearly 25 times the IEPA soil objective of 3,500 ppb. IEPA reportedly granted closure with respect to groundwater monitoring since no constituents were detected above Class II standards. A risk analysis was performed for methanol and PNAs, the only constituents above IEPA soil objectives. Results reportedly indicated that levels of risk were a minimum of two orders of magnitude below U.S. EPA action levels. Certification of closure documentation is currently under review by IEPA.

Description: View of the area where the Former Product and Hazardous Waste Underground Storage Tank Area (SWMU 6) was located. SWMU is currently paved with asphalt.

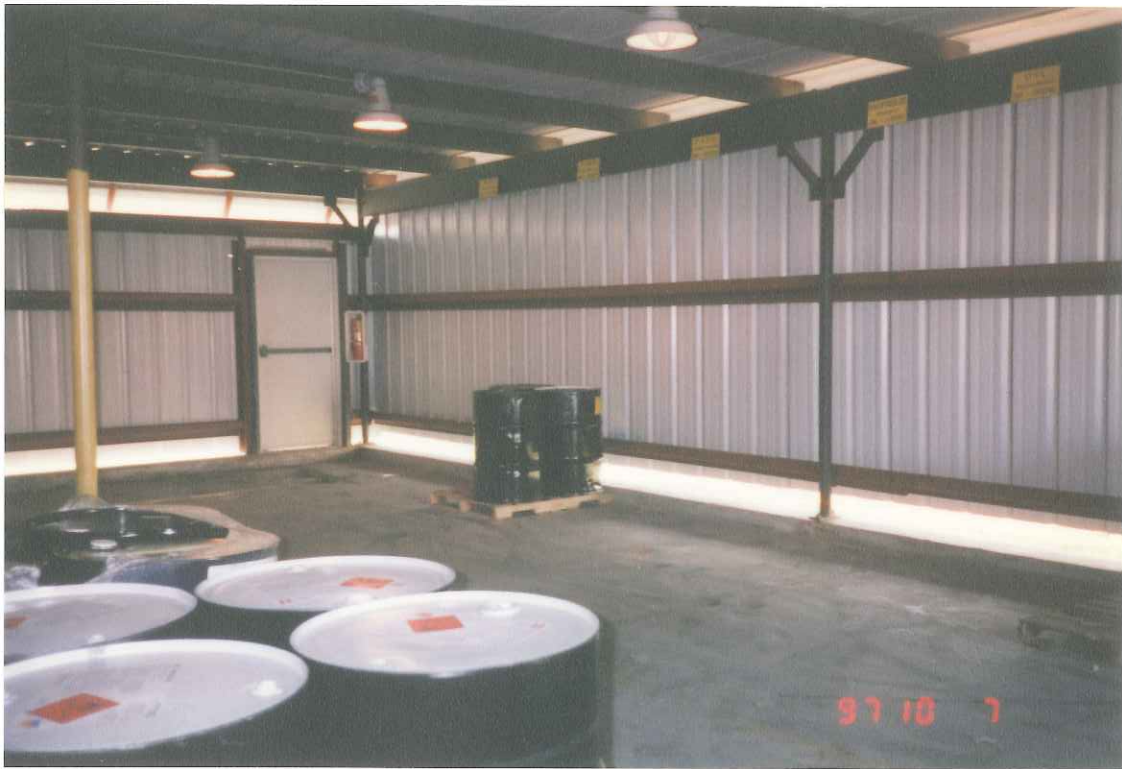
Report Photo No.: 8  
Log Book Photo No.: 1-10  
Date: 10/7/97

Description: View of the western portion of the Hazardous Waste Storage Shed (SWMU 7). Note the curbing and sloping floor to the north. Product drums appear in the foreground.

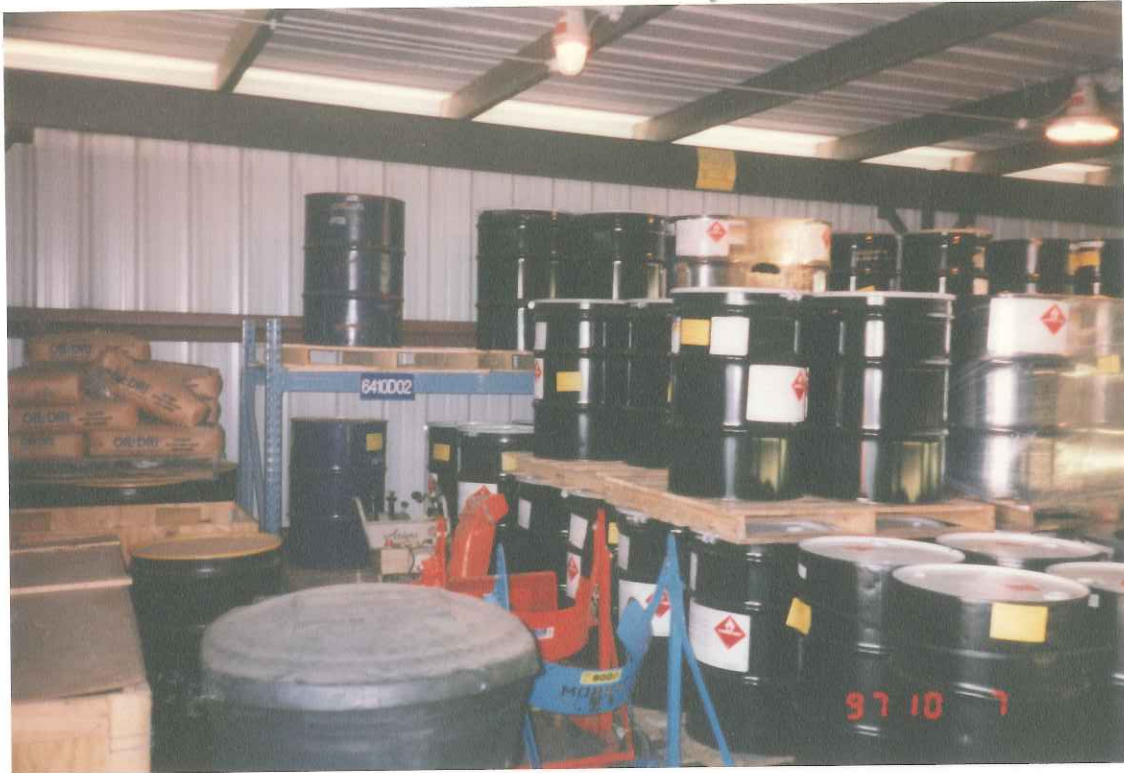
Report Photo No.: 9  
Log Book Photo No.: 1-11  
Date: 10/7/97

Description: View of the eastern portion of the Hazardous Waste Storage Shed (SWMU 7). Wastes containing PCBs are stored in the drum with a yellow lid while other drums contain product.

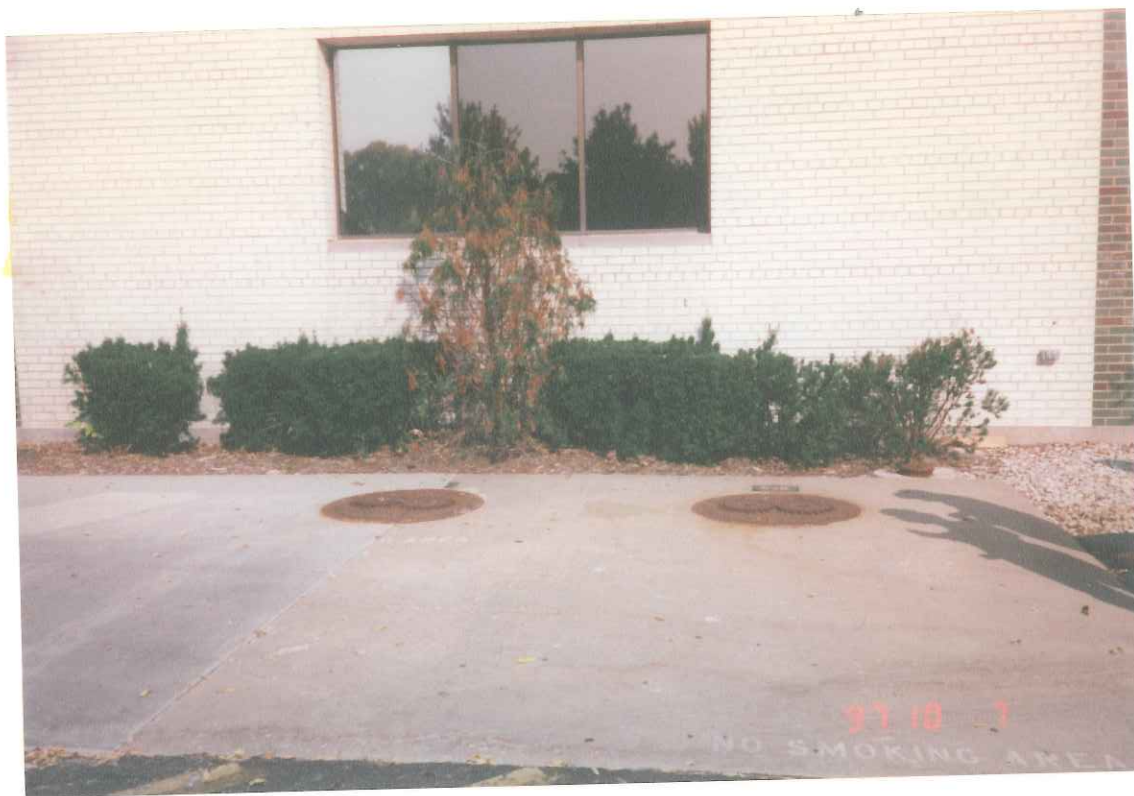
Report Photo No.: 10  
Log Book Photo No.: 1-14  
Date: 10/7/97

Description: View of the Current and Former Underground Storage Tank Area (AOC A). Access covers are marked MEK (right) and 1090 Blend (left). Note stressed vegetation as indicated by the unhealthy evergreen.

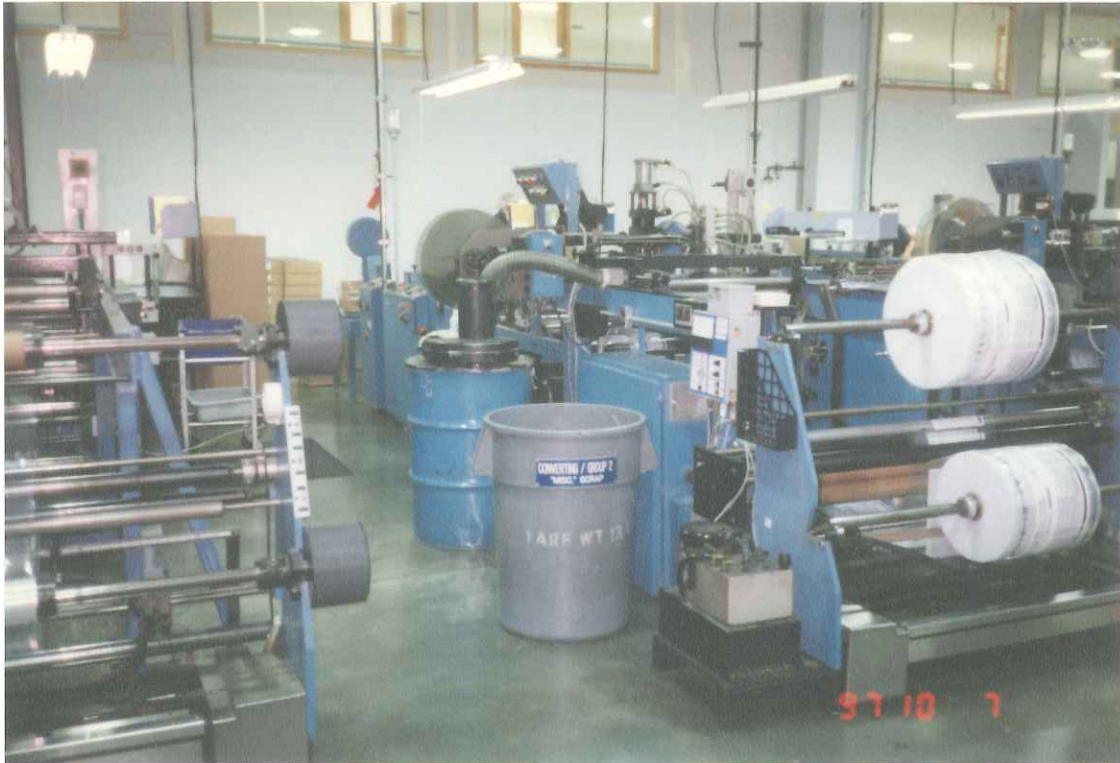
Report Photo No.: 11  
Log Book Photo No.: 1-1  
Date: 10/7/97

Description: View of a recycling containers. Tyvek scrap generated by the manufacturing process is removed from machinery by vacuum (mounted on top of drum) and collected in drums. Scrap plastics are collected in the open container.

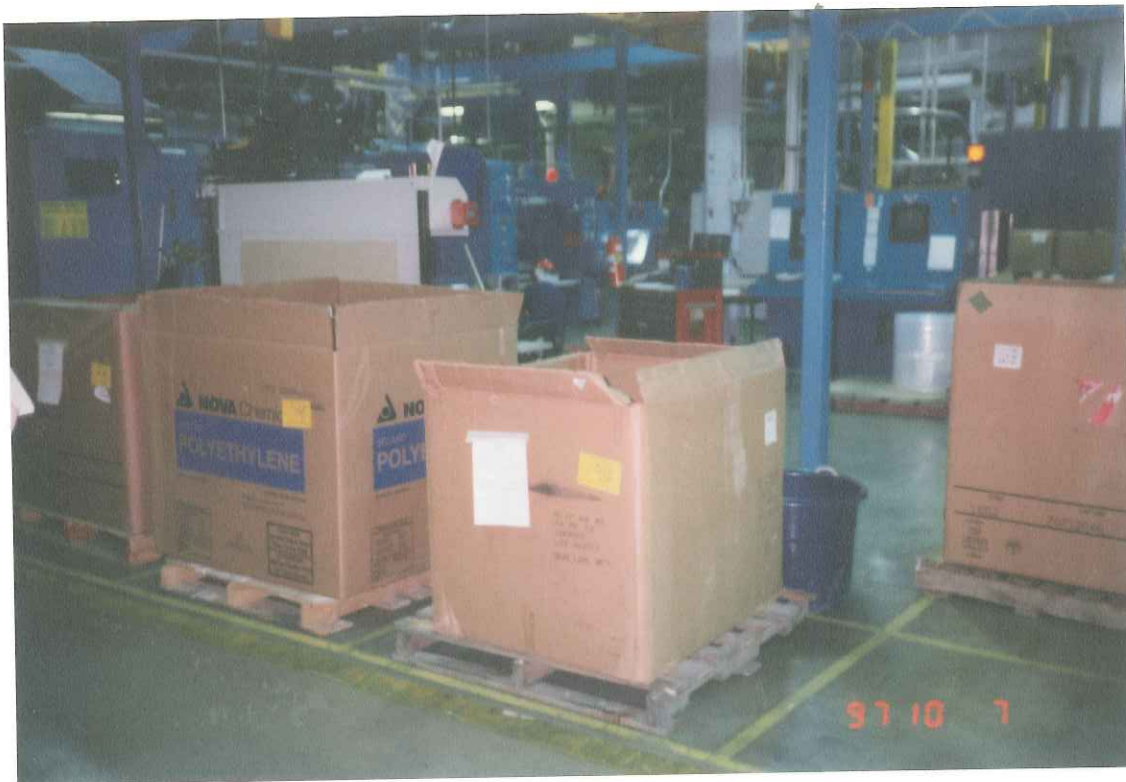
Report Photo No.: 12  
Log Book Photo No.: 1-4  
Date: 10/7/97

Description: View of a scrap plastic in boxes to be recycled.

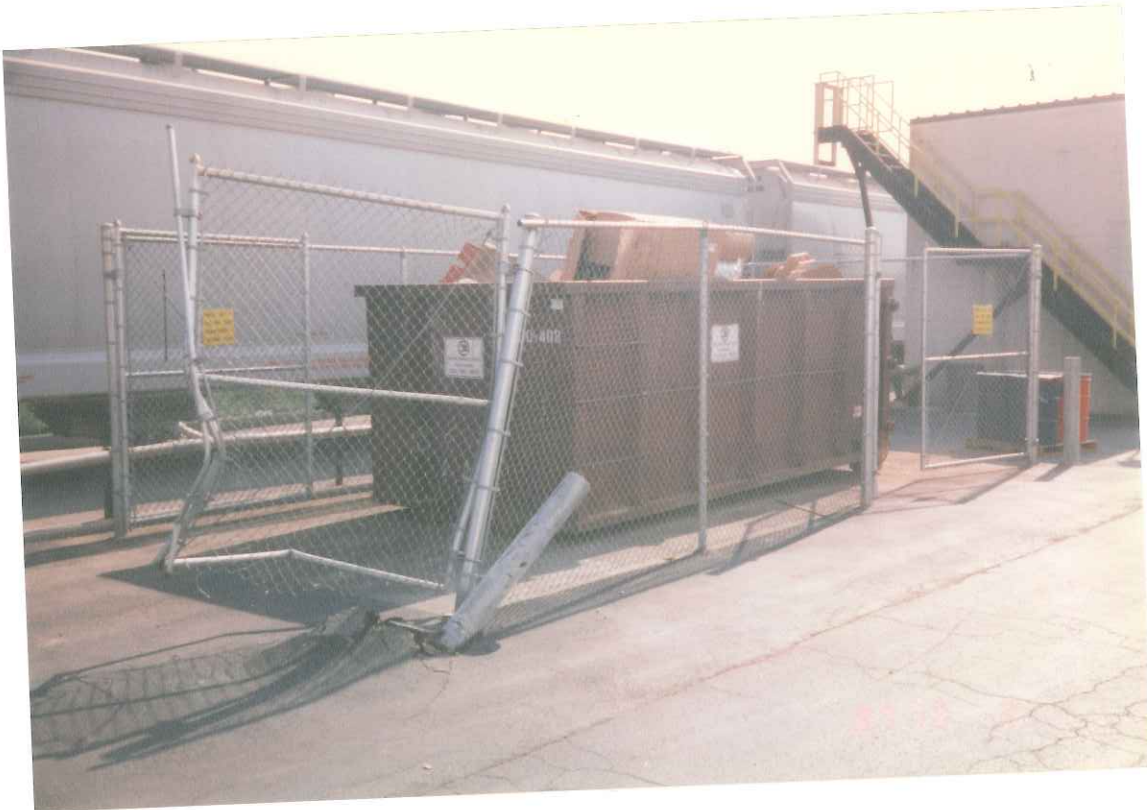
Report Photo No.: 13  
Log Book Photo No.: 1-12  
Date: 10/7/97

Description: View of Dumpster. Note broken fence surrounding dumpster.
